LOYALIST TOWNSHIP

**GEOTECHNICAL AND  
HYDROGEOLOGICAL INVESTIGATION  
AMHERSTVIEW SECONDARY PLAN  
KINGSTON, ONTARIO**

OCTOBER 15, 2021 (UPDATED)

PROJECT NO.: 211-01353-00  
ORIGINAL: AUGUST 2021  
DATE UPDATED: OCTOBER 2021

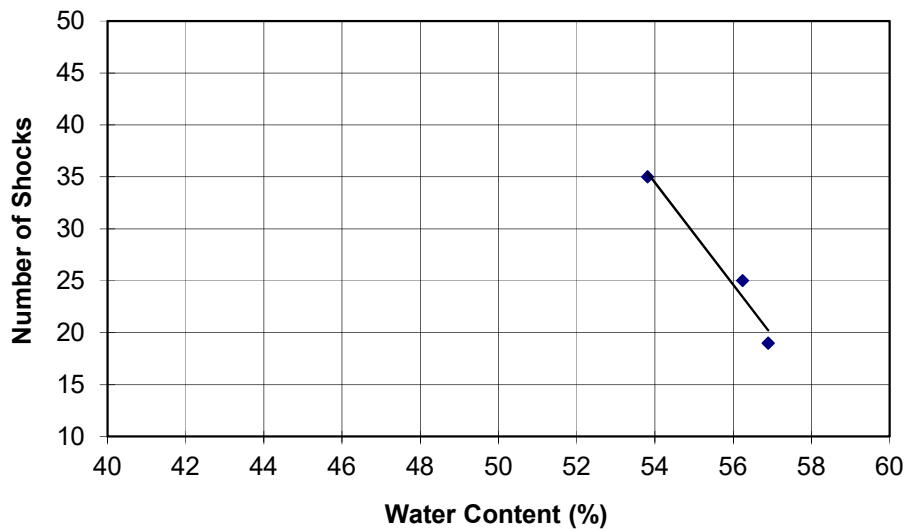
### Liquid Limit

Liquid Limit, ( $W_L$ )	<u>31</u>
Plastic Limit, (WP)	<u>19</u>
Plasticity Index ( $I_p=W_L-W_p$ )	<u>12</u>

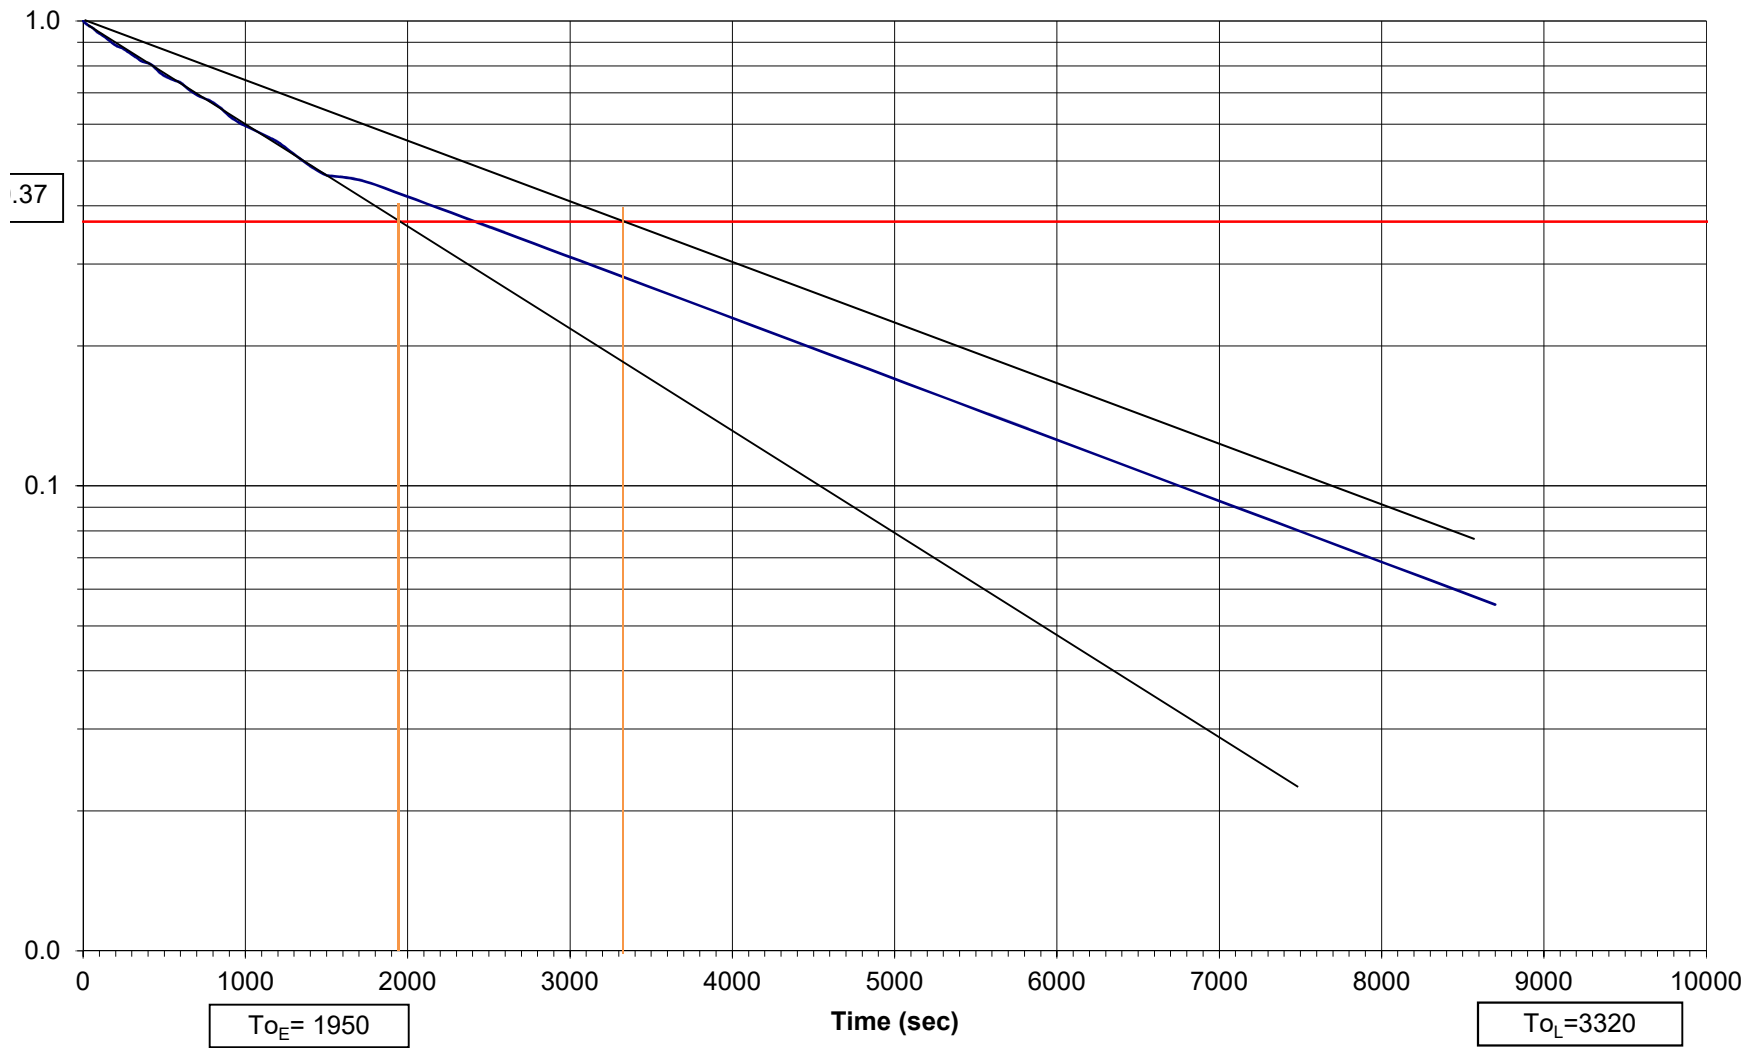
### Hvorslev Testing: BH21-03

Time t (sec)	H-h	H-Ho	(H-h)/(H-Ho)
0	1.440	1.440	1.000
30	1.410	1.440	0.979
60	1.390	1.440	0.965
90	1.360	1.440	0.944
120	1.340	1.440	0.931
150	1.315	1.440	0.913
180	1.290	1.440	0.896
210	1.270	1.440	0.882
240	1.260	1.440	0.875
270	1.240	1.440	0.861
330	1.200	1.440	0.833
360	1.180	1.440	0.819
420	1.160	1.440	0.806
480	1.110	1.440	0.771
540	1.080	1.440	0.750
600	1.060	1.440	0.736
660	1.020	1.440	0.708
720	0.990	1.440	0.688
780	0.970	1.440	0.674
840	0.940	1.440	0.653
900	0.900	1.440	0.625
960	0.870	1.440	0.604
1020	0.850	1.440	0.590
1080	0.830	1.440	0.576
1140	0.810	1.440	0.563
1200	0.790	1.440	0.549
1500	0.670	1.440	0.465
1800	0.640	1.440	0.444
8700	0.080	1.440	0.056

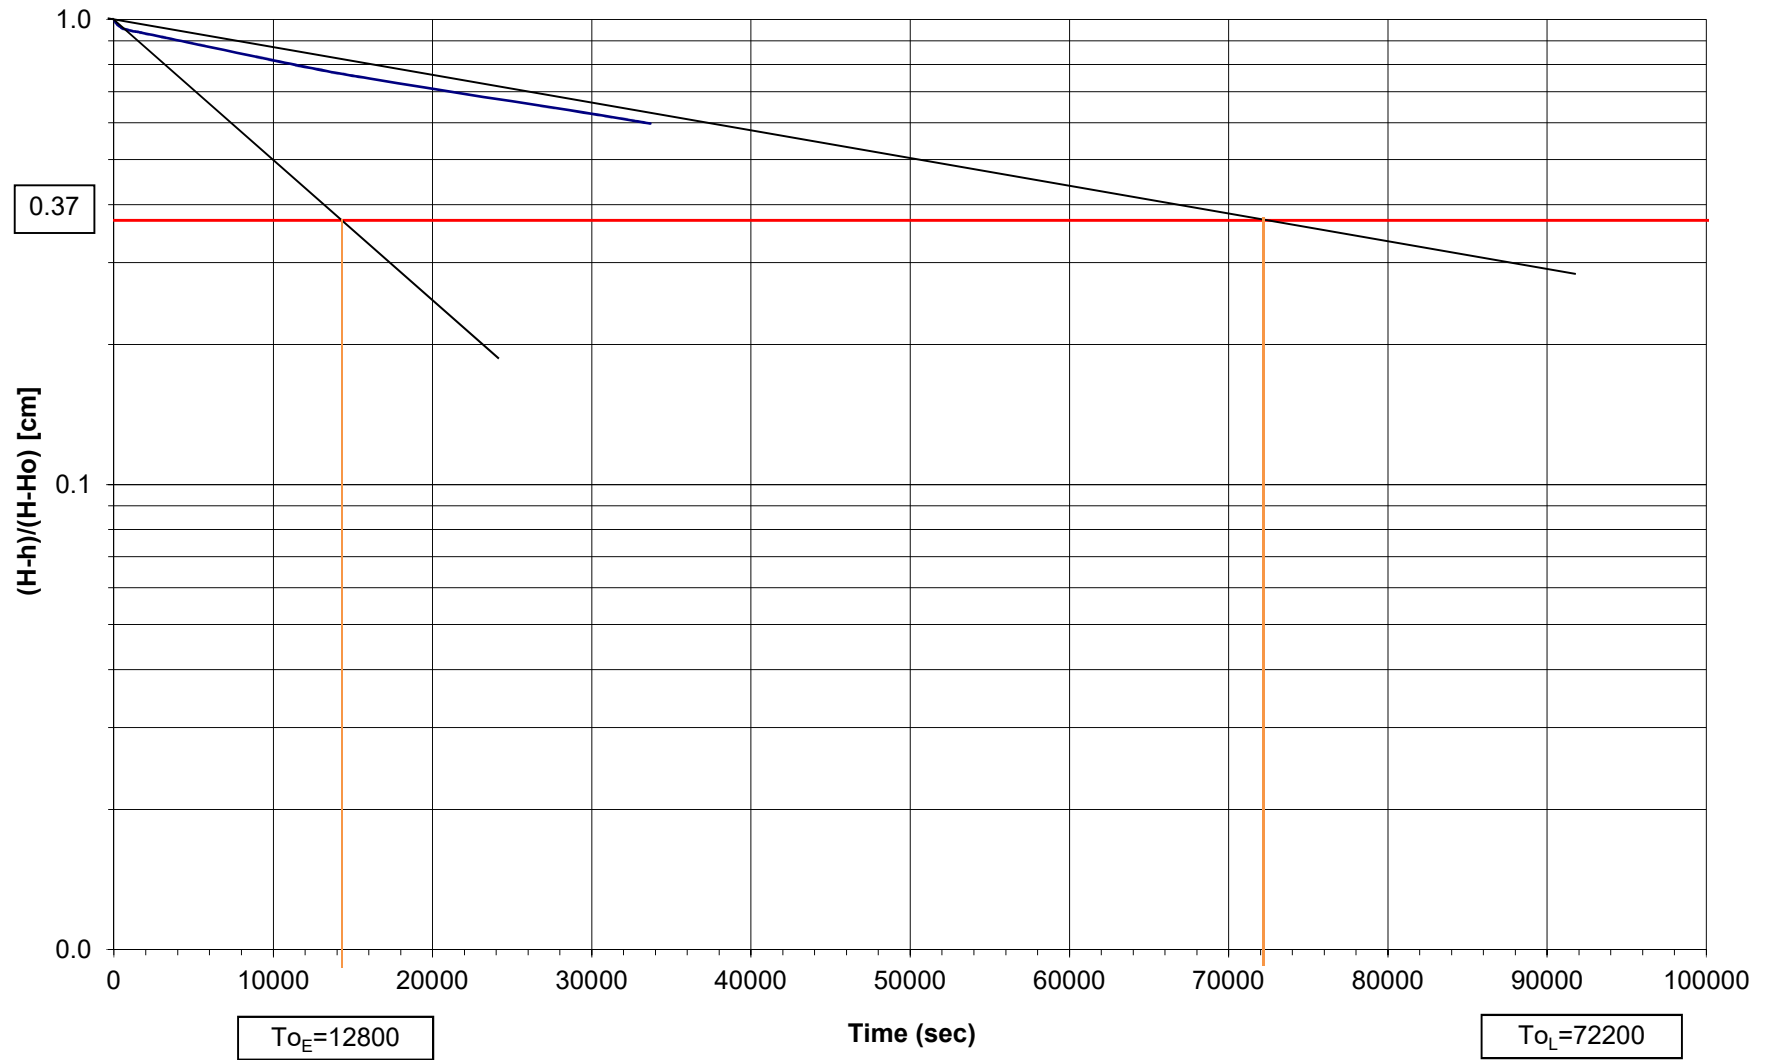
### Hvorslev Testing: BH21-09

Project No.:	211-01353-00	H = Static Water Level	mbg
Project Name:	Loyalist Secondary Plan	Ho = Head at time = 0	mbg
Date:	15-Jun-21	h = Water Level at time t	mbg
Conducted by:	LG/DAY	To <sub>E</sub> =	12800 sec
Well Number:	BH21-09	To <sub>L</sub> =	72,200 sec
Well Depth:	6.34 mbgs	Screen Length (L) =	152.4 cm
Top of Pipe:	1.02 mag	Hole Radius (R) =	15.2 cm
Well Diameter:	51 mm	Well Radius (r) =	2.55 cm (measured)
Well Elevation:	91.85 masl		
Static Water Level:	2.45 mbtop	$K_E = r^2 \ln(L/R) / (2LT_o) =$	3.84E-06 cm/s
Ground Elevation:	90.74 masl	$K_L = r^2 \ln(L/R) / (2LT_o) =$	6.81E-07 cm/s

Time t (sec)	H-h	H-Ho	(H-h)/(H-Ho)
0	4.180	4.150	1.007
35	4.150	4.150	1.000
60	4.120	4.150	0.993
90	4.095	4.150	0.987
120	4.080	4.150	0.983
150	4.070	4.150	0.981
180	4.060	4.150	0.978
210	4.045	4.150	0.975
240	4.040	4.150	0.973
270	4.030	4.150	0.971
300	4.020	4.150	0.969
360	4.010	4.150	0.966
420	3.995	4.150	0.963
480	3.980	4.150	0.959
540	3.970	4.150	0.957
600	3.965	4.150	0.955
660	3.960	4.150	0.954
720	3.955	4.150	0.953
780	3.950	4.150	0.952
840	3.945	4.150	0.951
900	3.940	4.150	0.949
960	3.935	4.150	0.948
1020	3.930	4.150	0.947
1080	3.925	4.150	0.946
1140	3.920	4.150	0.945
1200	3.915	4.150	0.943

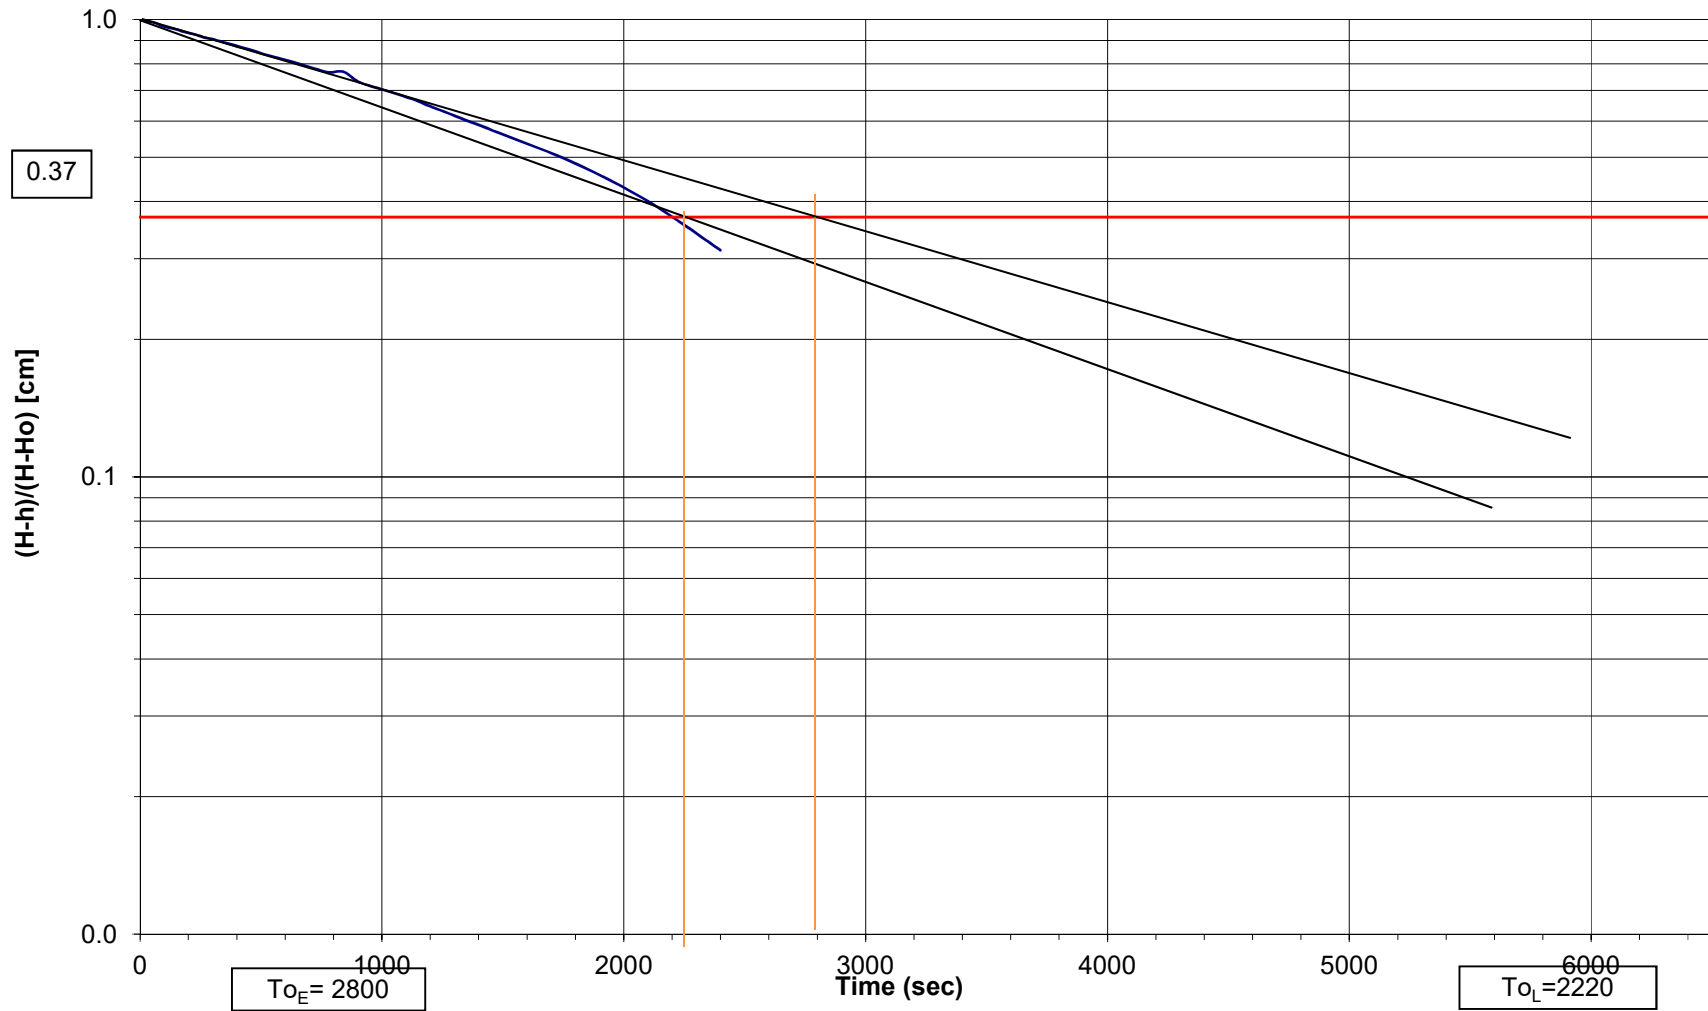
# Hvorslev Testing: MW20-4

Project No.:	211-01353-00	H = Static Water Level	mbg
Project Name:	Loyalist Secondary Plan	Ho = Head at time = 0	mbg
Date:	15-Jun-21	h = Water Level at time t	mbg
Conducted by:	LG/DAY	To <sub>E</sub> =	2800 sec
Well Number:	MW20-4	To <sub>L</sub> =	2220 sec
Well Depth:	2.64 mbgs	Screen Length (L) =	152.4 cm
Top of Pipe:	0.89 mag	Hole Radius (R) =	10.414 cm
Well Diameter:	51 mm	Well Radius (r) =	2.55 cm (measured)
Well Elevation:	127.54 masl		
Static Water Level:	2.08 mbtop	$K_E = r^2 \ln(L/R) / (2LT_o) =$	2.04E-05 cm/s
Ground Elevation:	126.50 masl	$K_L = r^2 \ln(L/R) / (2LT_o) =$	2.58E-05 cm/s

Time t (sec)	H-h	H-Ho	(H-h)/(H-Ho)
0	2.620	2.620	1.000
25	2.600	2.620	0.992
60	2.580	2.620	0.985
90	2.540	2.620	0.969
120	2.515	2.620	0.960
150	2.495	2.620	0.952
180	2.465	2.620	0.941
240	2.420	2.620	0.924
270	2.390	2.620	0.912
300	2.375	2.620	0.906
360	2.325	2.620	0.887
420	2.280	2.620	0.870
480	2.230	2.620	0.851
540	2.180	2.620	0.832
600	2.140	2.620	0.817
660	2.095	2.620	0.800
720	2.050	2.620	0.782
780	2.010	2.620	0.767
840	2.015	2.620	0.769
900	1.920	2.620	0.733
960	1.870	2.620	0.714
1020	1.830	2.620	0.698
1080	1.788	2.620	0.682
1140	1.745	2.620	0.666
1200	1.693	2.620	0.646
1500	1.470	2.620	0.561
1800	1.270	2.620	0.485
2100	1.050	2.620	0.401
2400	0.820	2.620	0.313

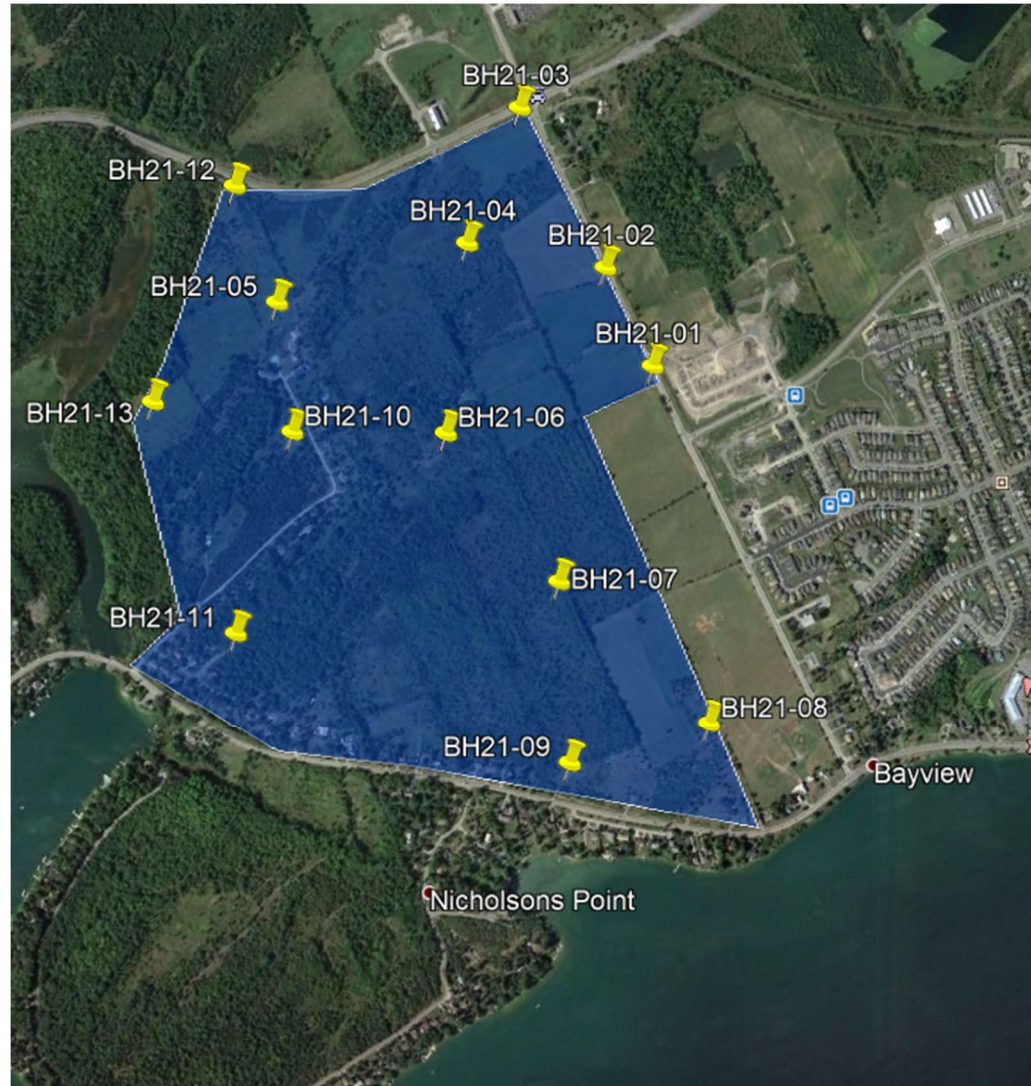
The survey began on April 5<sup>th</sup> and was completed on April 6<sup>th</sup>. Figure 1 shows the boundary area (blue) of interest that is looking to be developed as well as the borehole locations overlaid on a Google Earth image. The operator gathered a total of 56 data files. The device that was used to complete the survey was the Mala GX (Ground Explorer) with the 450MHz antenna, which is linked directly to the Global Positioning System (GPS). A fact sheet has been attached in Appendix A. The device was set in time-mode which simply means the device is always recording, regardless if the operator is moving or not. A conservative estimate of the total amount of linear profiles covered was 18.0 kilometers.

Figure 1: Survey Area with borehole locations marked

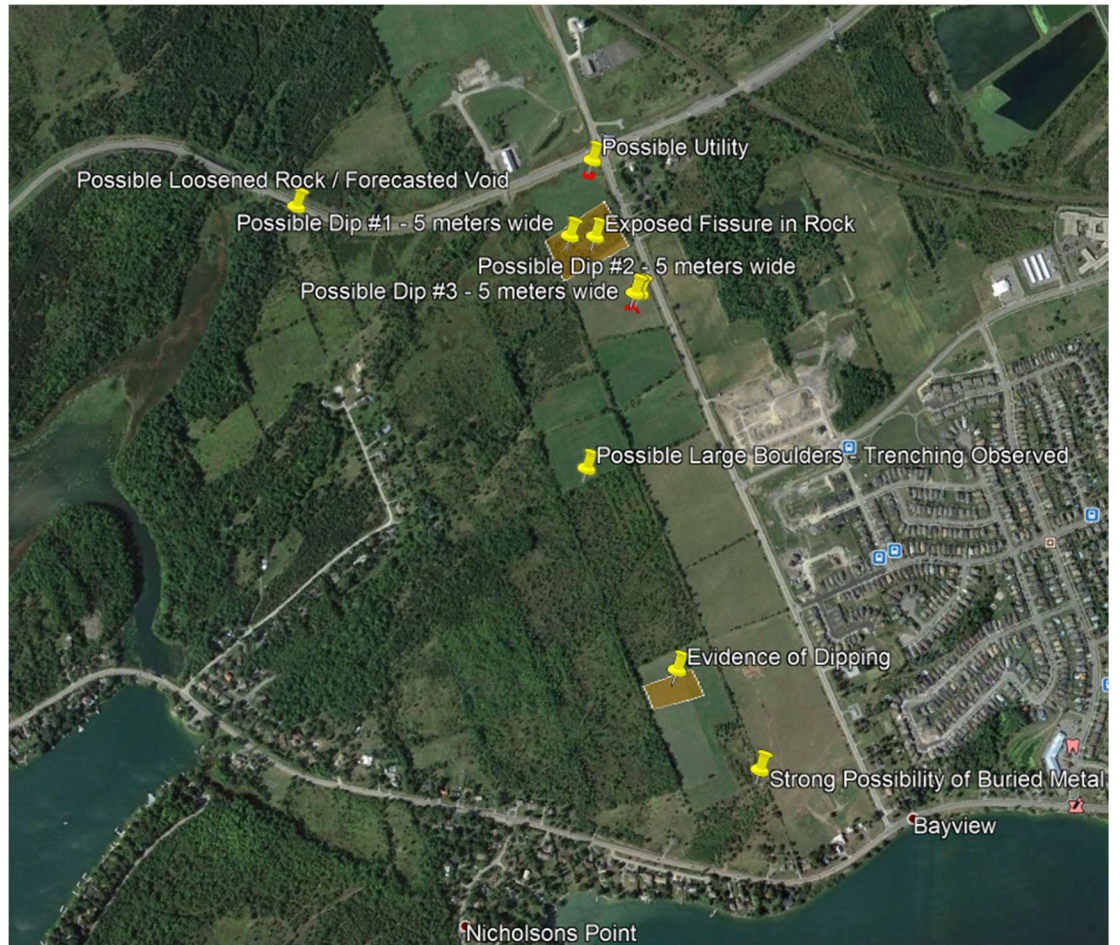
Figure 4: Anomaly Map

Anomaly Name	Easting (m) +/- 1m	Northing (m) +/- 1m	Approximate Depth (m)
Possible Loosened Rock / Forecasted Void	365521	4898392	2
Possible Utility	366213	4898519	0.5
Possible Dip #1	366165	4898337	2
Exposed Fissure in Rock	366224	4898338	0
Possible Dip #2	366333	4898208	2.5
Possible Dip #3	366321	4898207	2.5
Possible Large Boulders / Trenching Observed	366218	4897795	1.5 - 2
Evidence of Dipping Zone	366372 - 366517	4897277 - 4897367	1.5 - 2
Strong Possibility of Buried Metal (Area)	366638	4897108	NA

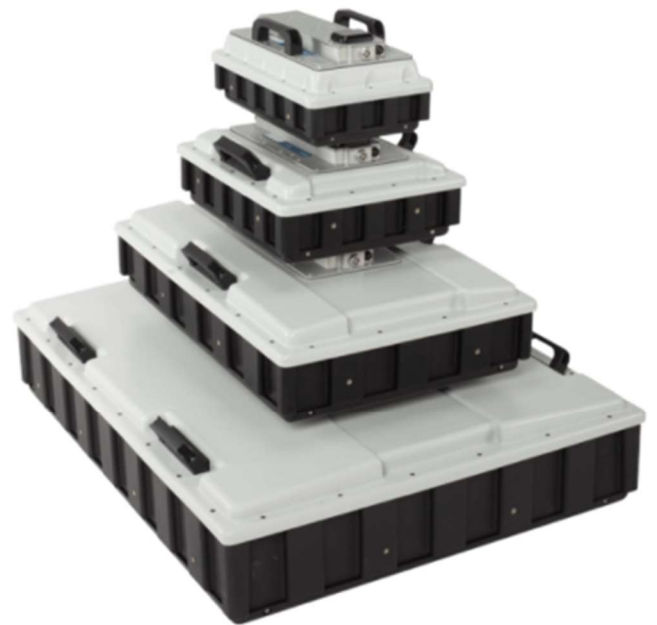
MALÅ GX is an integrated GPR solution with four MALÅ GX antenna options: GX80, GX160, GX450 and GX750.

MALÅ GX can be optimized for specific measurements and applications by adding different antennas. For the GX-series of antennas, there are four options to choose from using center-frequencies of 80, 160, 450 or 750MHz. The choice of antenna frequency will be governed by your application and the desired depth penetration and resolution. All new MALÅ GX antennas are app-enabled, and comes with WiFi connection per default. This enables full integration with MALÅ Controller app and MALÅ Vision.

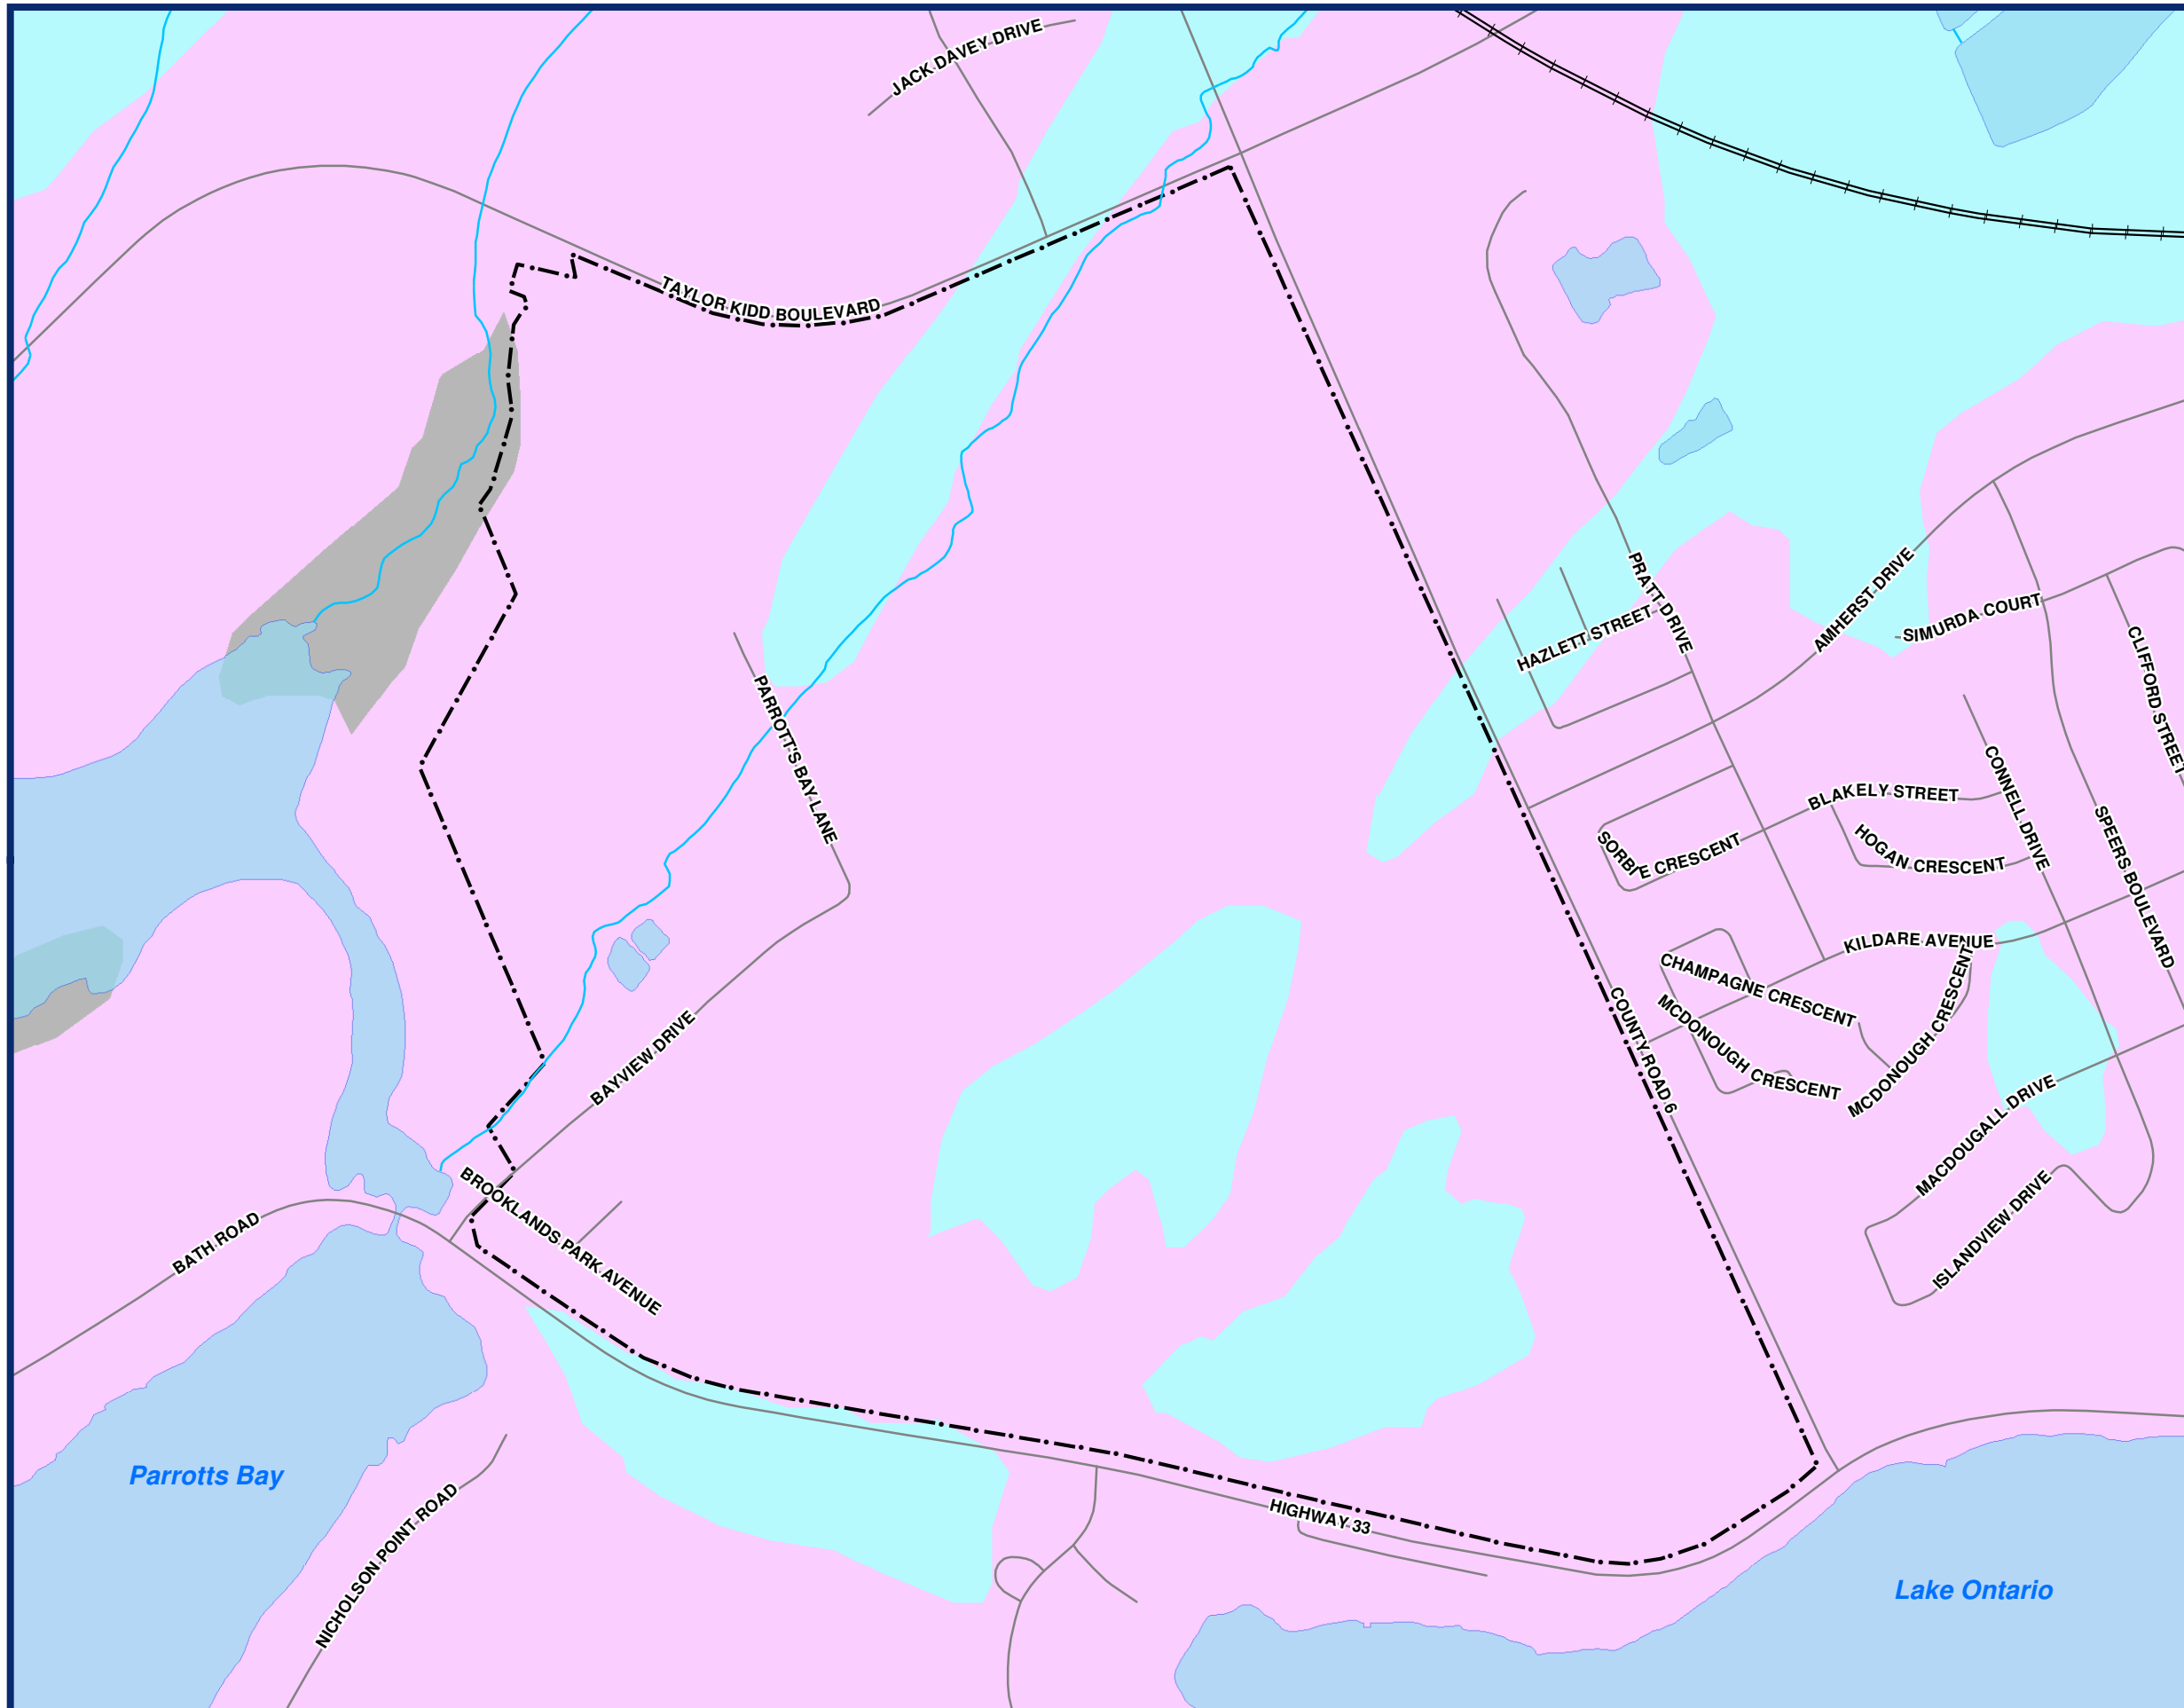
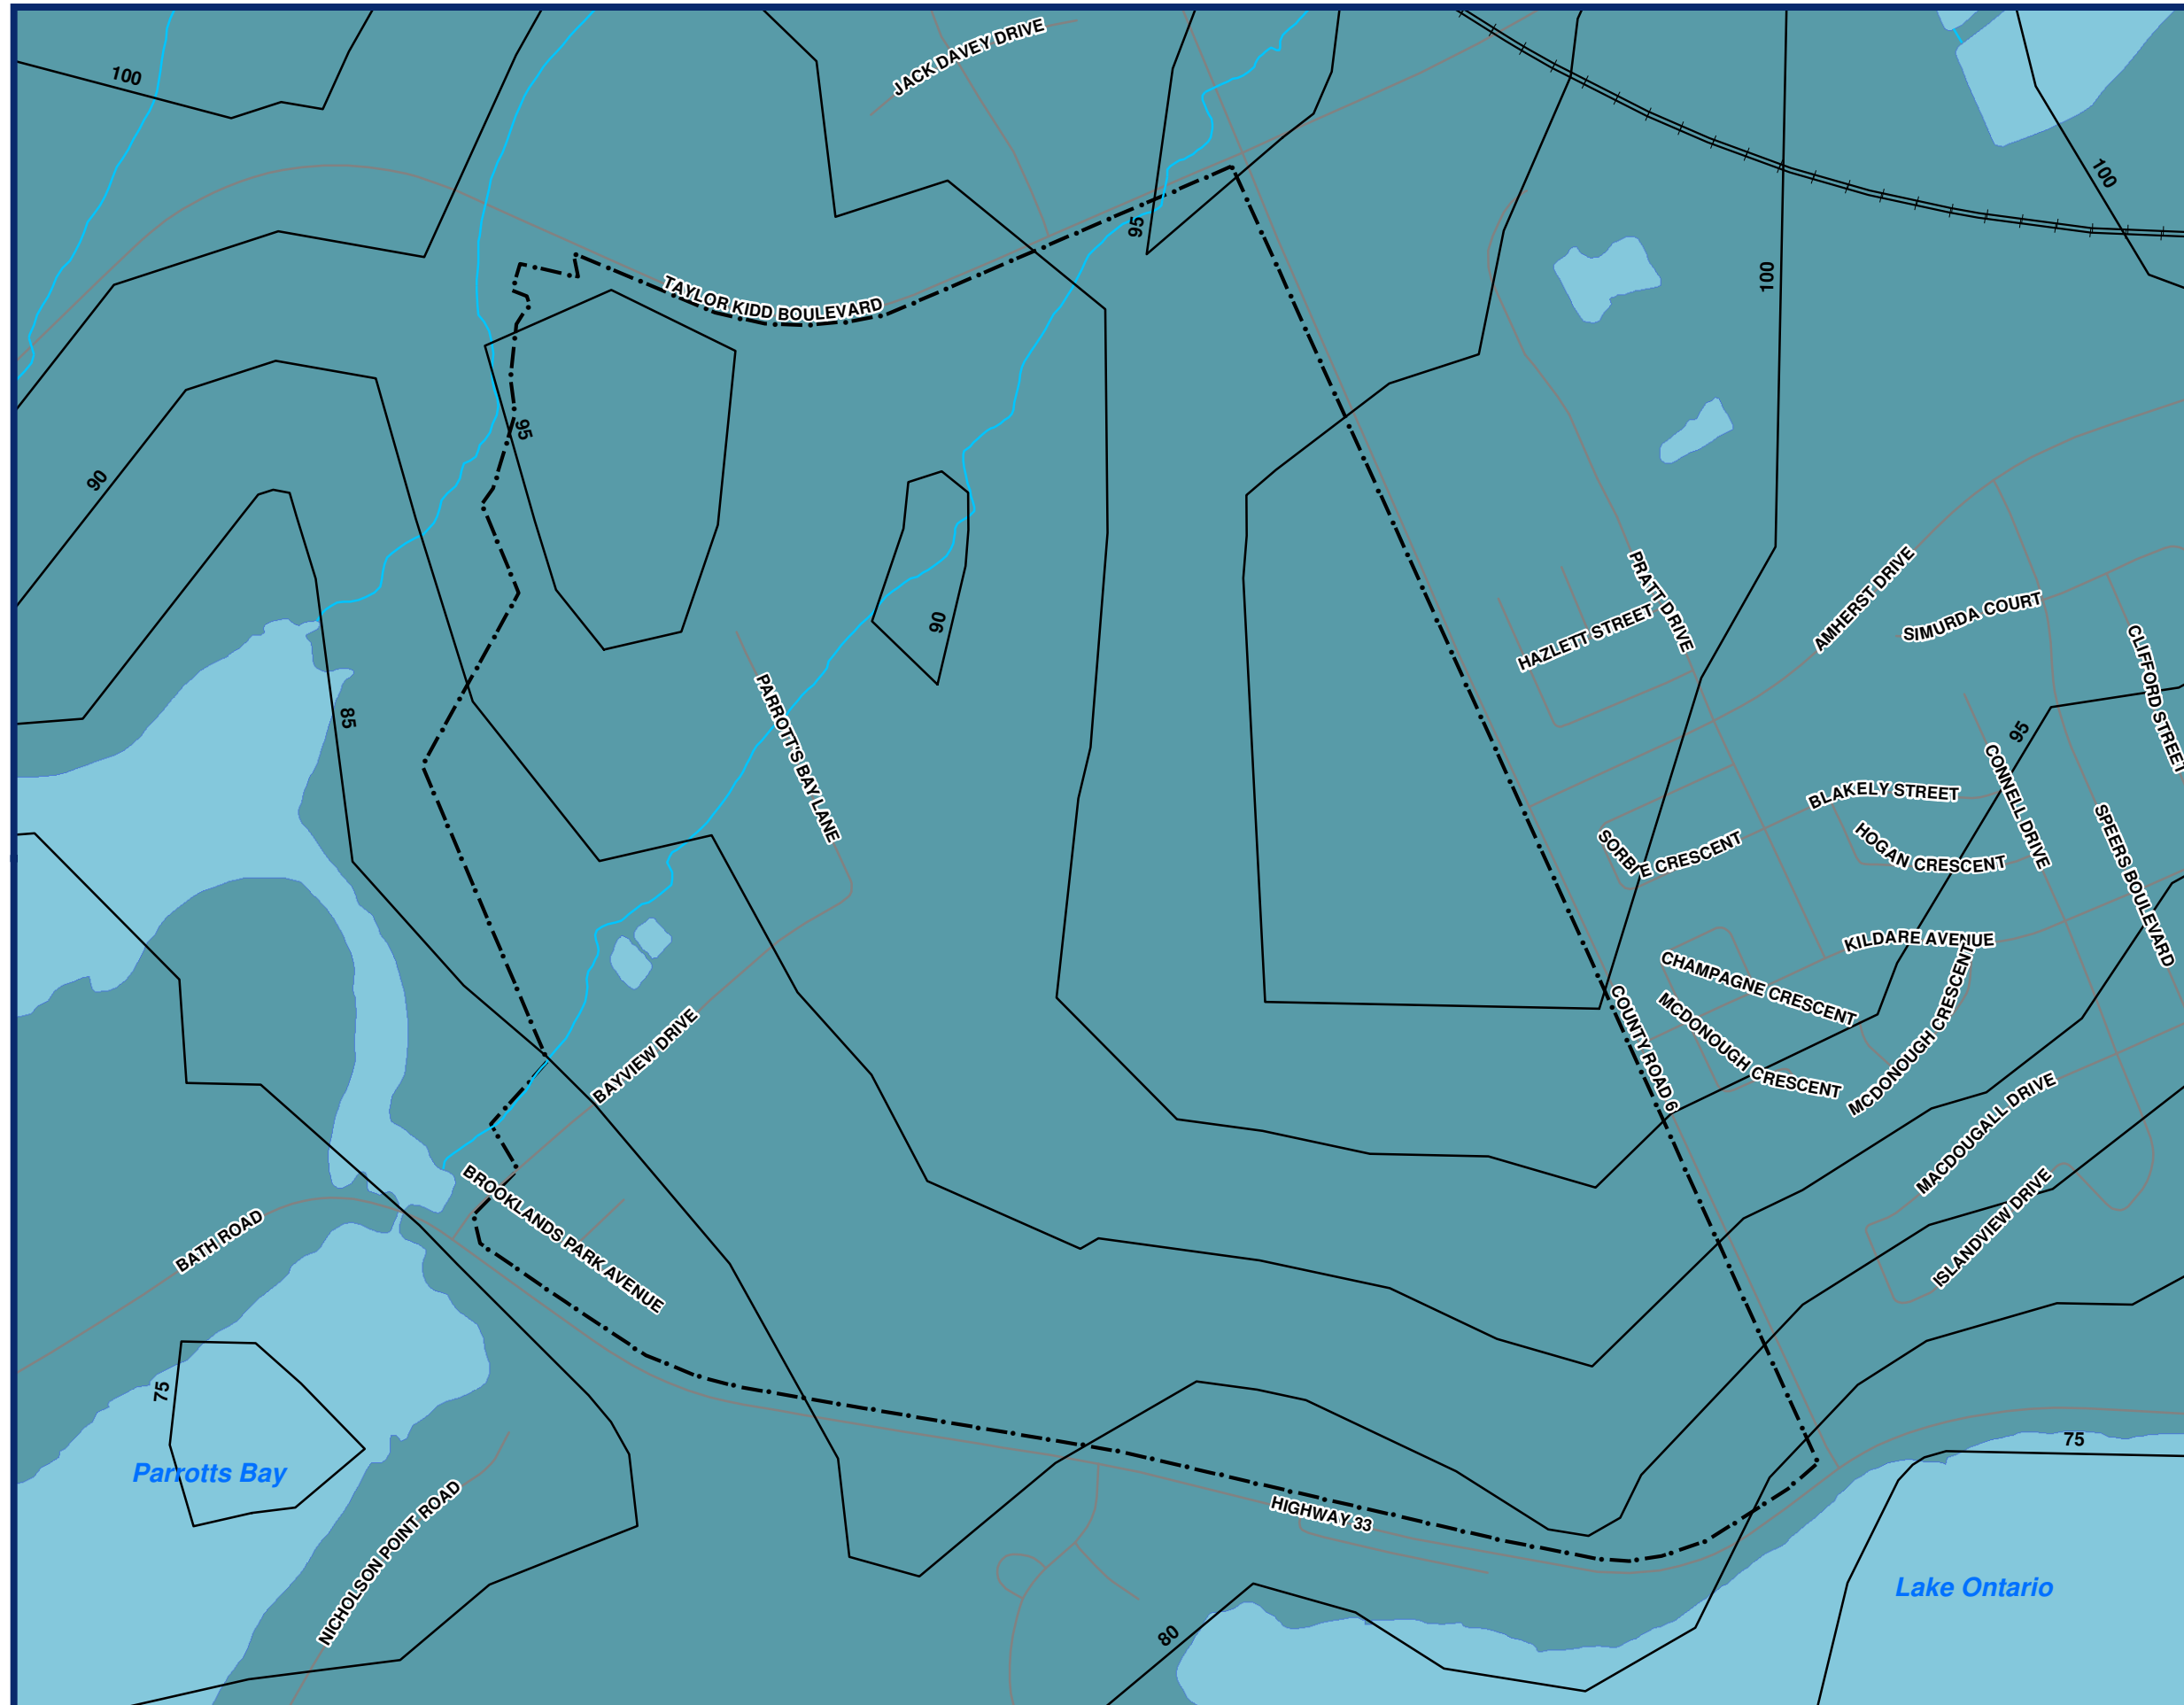
**Figure 5**  
**Bedrock Geology &**  
**Bedrock Topography**

BEDROCK ELEVATION (mASL) (5m INTERVAL)

The bedrock underlying the Site consists primarily of lithographic to fine-crystalline limestone, silty dolostone, shale and fine-grained calcareous quartz sandstone of the Gull River Formation (Ontario Geological Survey, 1999) (**Figure 5**). The bedrock is typically found within 1 m of surface, as shown in **Figure 5**. Outcrops of limestone are found throughout the Site.
